**BUREAU OF RECLAMATION
TECHNICAL SERVICE CENTER
DENVER, COLORADO**

TRAVEL REPORT

Date: April 7, 2006

Subject: Travel to Carlsbad, New Mexico, to provide flow measurement assistance to the Carlsbad Irrigation District

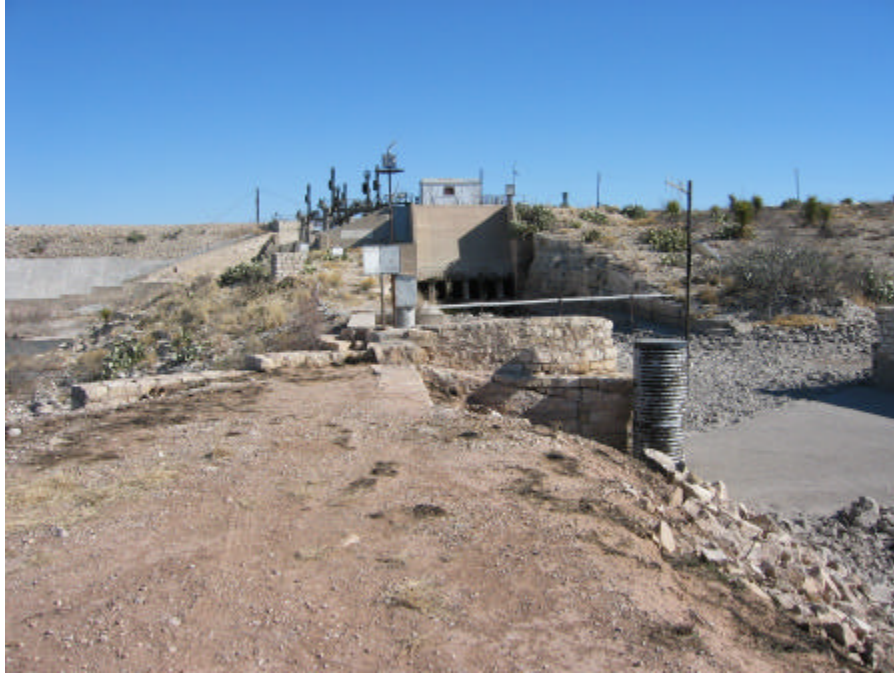
Figure 1—Headworks of the Carlsbad Irrigation District system at Avalon Dam.

Tom, Woodrow, and I then drove out to the construction site, located off Callaway Drive in the northwest corner of town. Water for the CID is released into the system from Avalon Dam (figure

1) on the Pecos River approximately 3 miles north of Carlsbad. The first control point downstream of the dam is located at the northwest corner of Carlsbad. At this location three independent gate structures control flow respectively into the East Canal, a wasteway back to the Pecos River, and the Southern (main) Canal, as shown in figure 2.

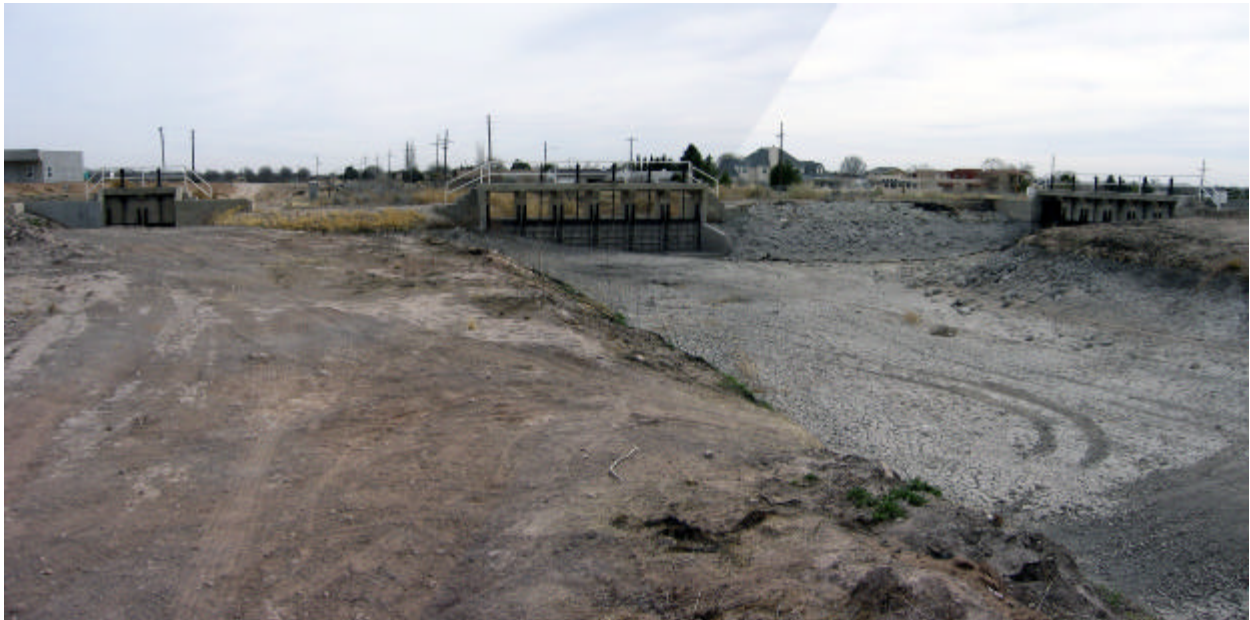
Figure 2—Gate structures for (from left to right) the East Canal, the wasteway to the Pecos River, and the Southern Canal, viewed from the upstream side.

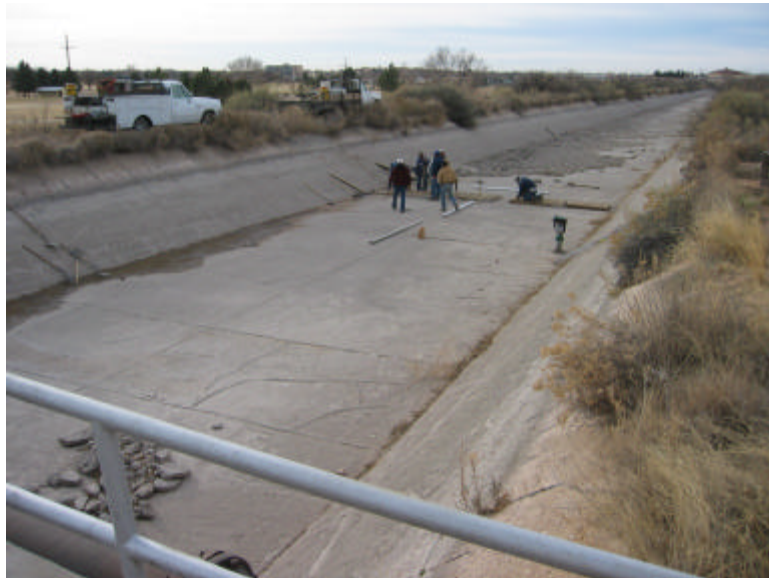
Figure 3—Proposed flume site in the Southern Canal as viewed from the Callaway Drive bridge looking downstream prior to construction.

The proposed flume construction site (figure 3) was in the Southern Canal, approximately 188 ft downstream from the control gates and 72.5 ft downstream from the Callaway Drive road bridge

(figure 4). The bridge features three 10-ft-wide by 8-ft-tall box openings, each box 48-ft-long in the flow direction and separated by 8-inch-thick walls. The canal section at the flume site is concrete lined and trapezoidal in shape, with a bottom width of approximately 30 ft, a depth of 7 ft, and a top width of 51 ft, yielding side slopes of 1.5:1. The estimated maximum discharge to be measured by the flume is 400 ft³/sec, and the existing high-water mark at the site indicates a flow depth of 4 ft.

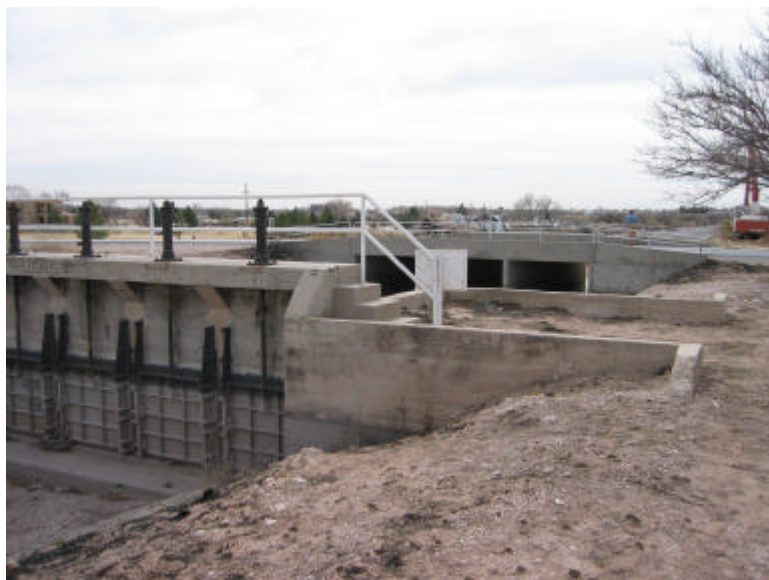
Figure 4—Southern Canal headgates (foreground) and Callaway Drive bridge (background) upstream from the flume construction site (hidden by the bridge).

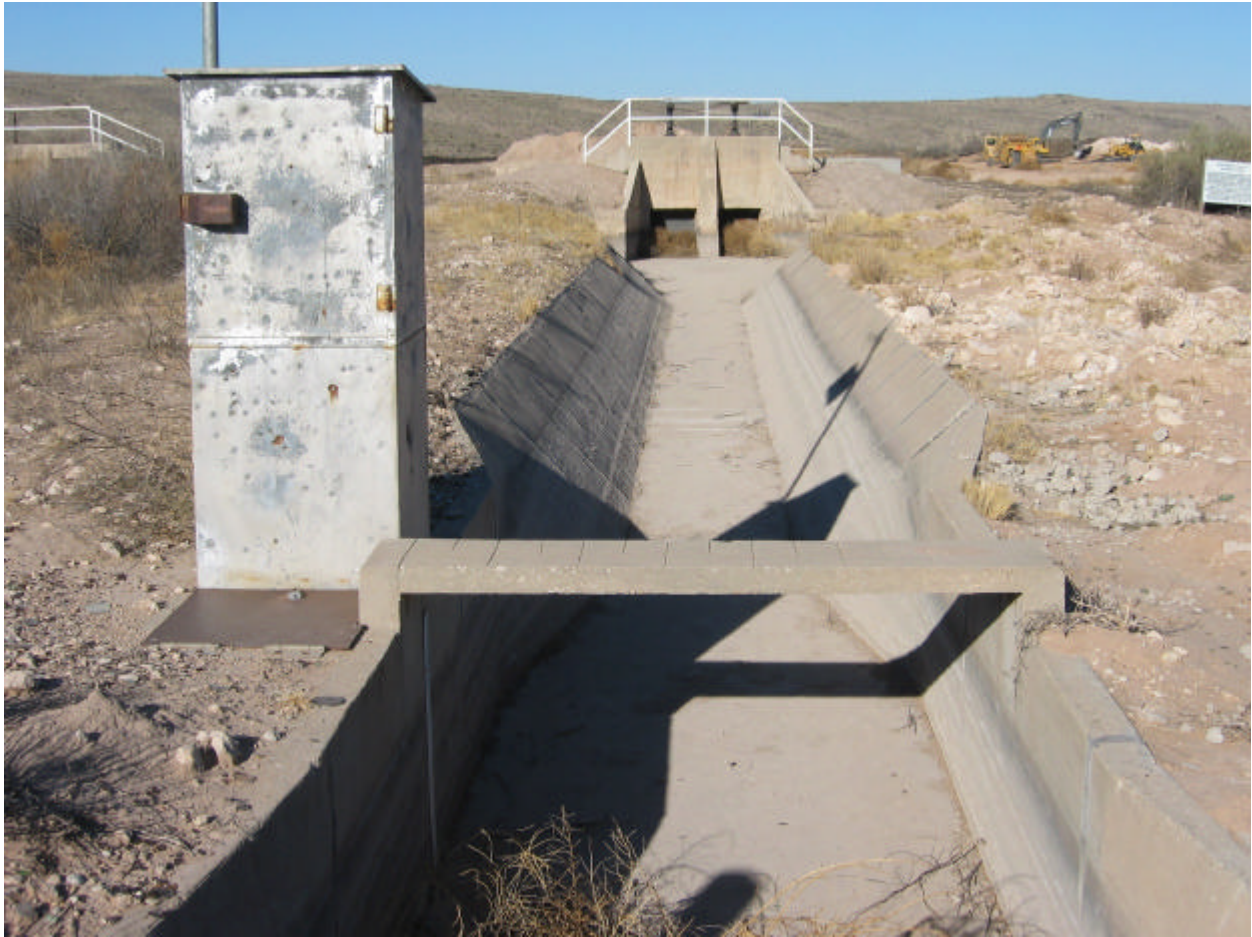
Figure 5—Initial reach of the East Canal viewed looking upstream from the abandoned USGS rated section and gage toward the headgate control structure.

Following the visit to the canal headworks, we looked at the gate control structure and initial reach of the East Canal (located in close proximity to the flume construction site on the Southern Canal). The district would like to measure discharge at the head end of the East Canal, similar to what the ramp flume is intended to achieve for the Southern Canal. The East Canal is significantly smaller than the Southern Canal. The initial reach features a concrete-lined trapezoidal channel with 1:1 side slopes, a bottom width of 4 ft, and a channel depth of 3.5 ft which decreases to 2.85 ft approximately 150 ft downstream from the headgate structure. The remnants of a USGS rated section are evident approximately 120 ft downstream from the headgate structure (figure 5). The rated section includes a 7-ft-wide rectangular section of channel 13.5 ft in length, with a staff gage, stilling well, gage house, and USGS Reference Mark on the right side of the channel. A concrete foot bridge across the rectangular channel section includes hash marks at 0.5 ft increments to facilitate propeller-meter velocity measurements and discharge computations through the section. High water marks in the channel indicate a maximum flow depth in the range of 2.0 to 2.1 ft for a reported maximum discharge of 30-35 ft³/sec. The discharges which the district would like to measure vary from a low of 8 ft³/sec up to the estimated maximum of 35 ft³/sec. Using a Kueffel & Esser Ni2 automatic level and a Philadelphia rod borrowed from the district, I collected elevation data in and around the initial reach of the East Canal to facilitate the design of a flow-measurement structure. I was assisted in this effort by Lupe, a member of the district maintenance staff.
